April 19, 2012

**Problem Statement**

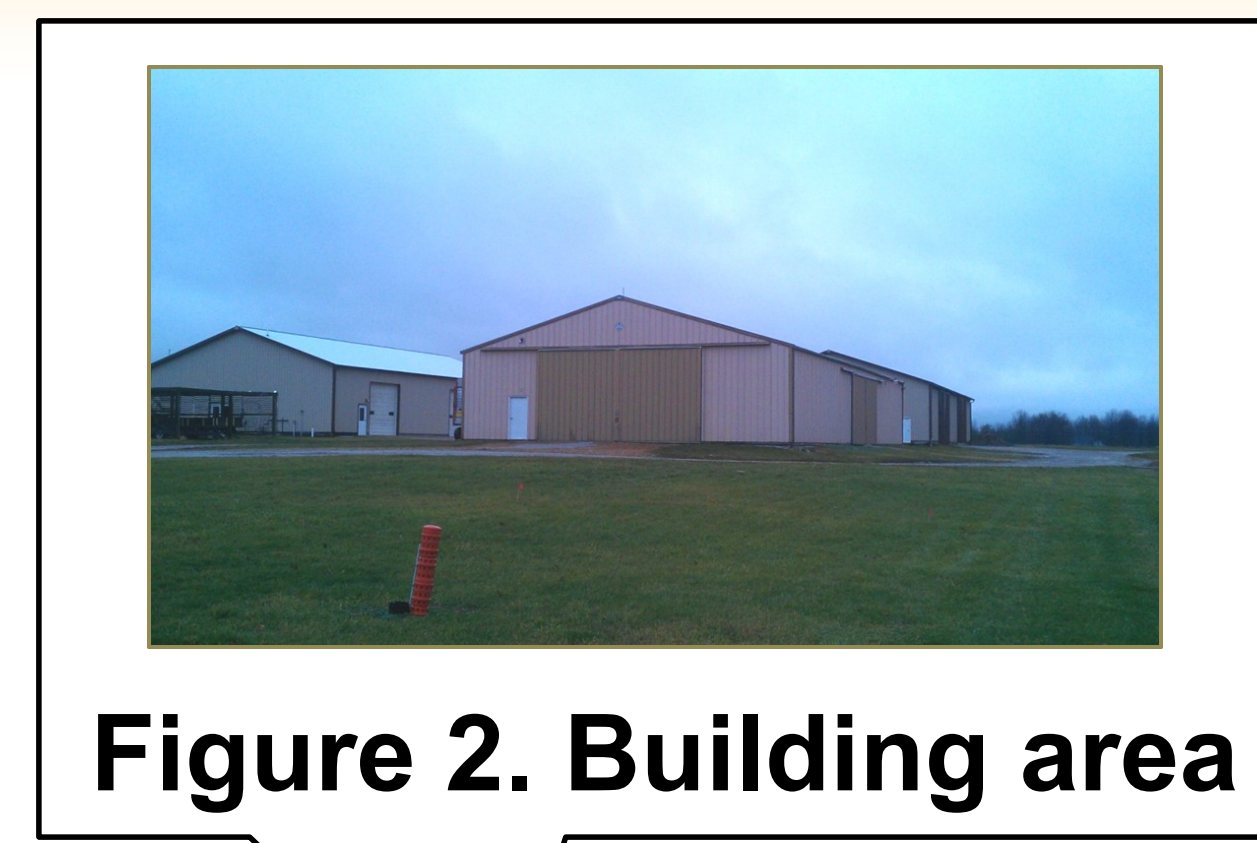
There is increased runoff at the Throckmorton-Purdue Agricultural Center due to newly constructed buildings (See Figures 1 and 2).

Figure 2. Building area

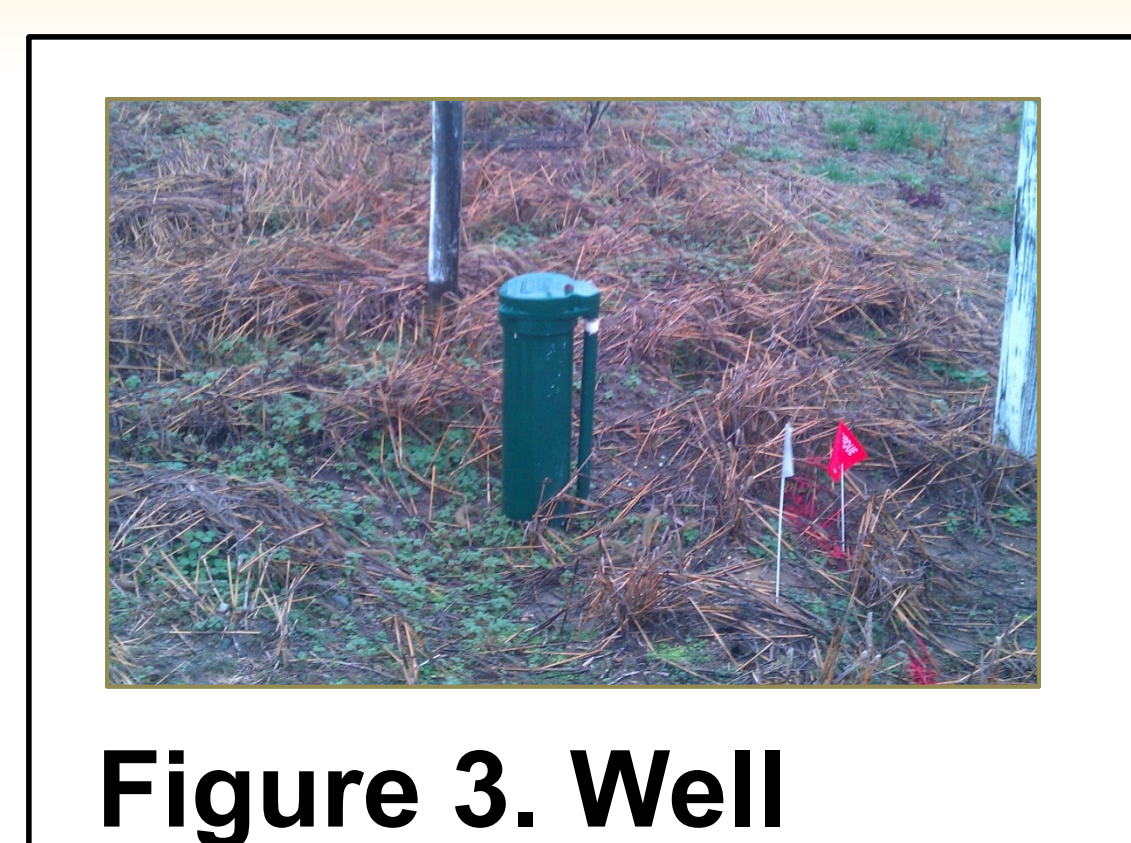
Land around two potable water wells on the east side of the project site is currently cultivated with the rest of the field with standard farm practices taking place around the wells. There is a concern for potential water contamination by pesticides (See Figure 3).

Figure 3. Well

The chosen solution was to replace existing clay tile with 10 inch, plastic, slotted corrugated tile in the same location as the existing tile to prevent future blowholes from the clay tile. This will allow the farm to maintain tillable acres. They also need to observe setbacks with a 50' radius around the potable water wells to ensure water quality (See Figure 5). The setbacks have been flagged so the farm managers can create a boundary line with GPS equipment.

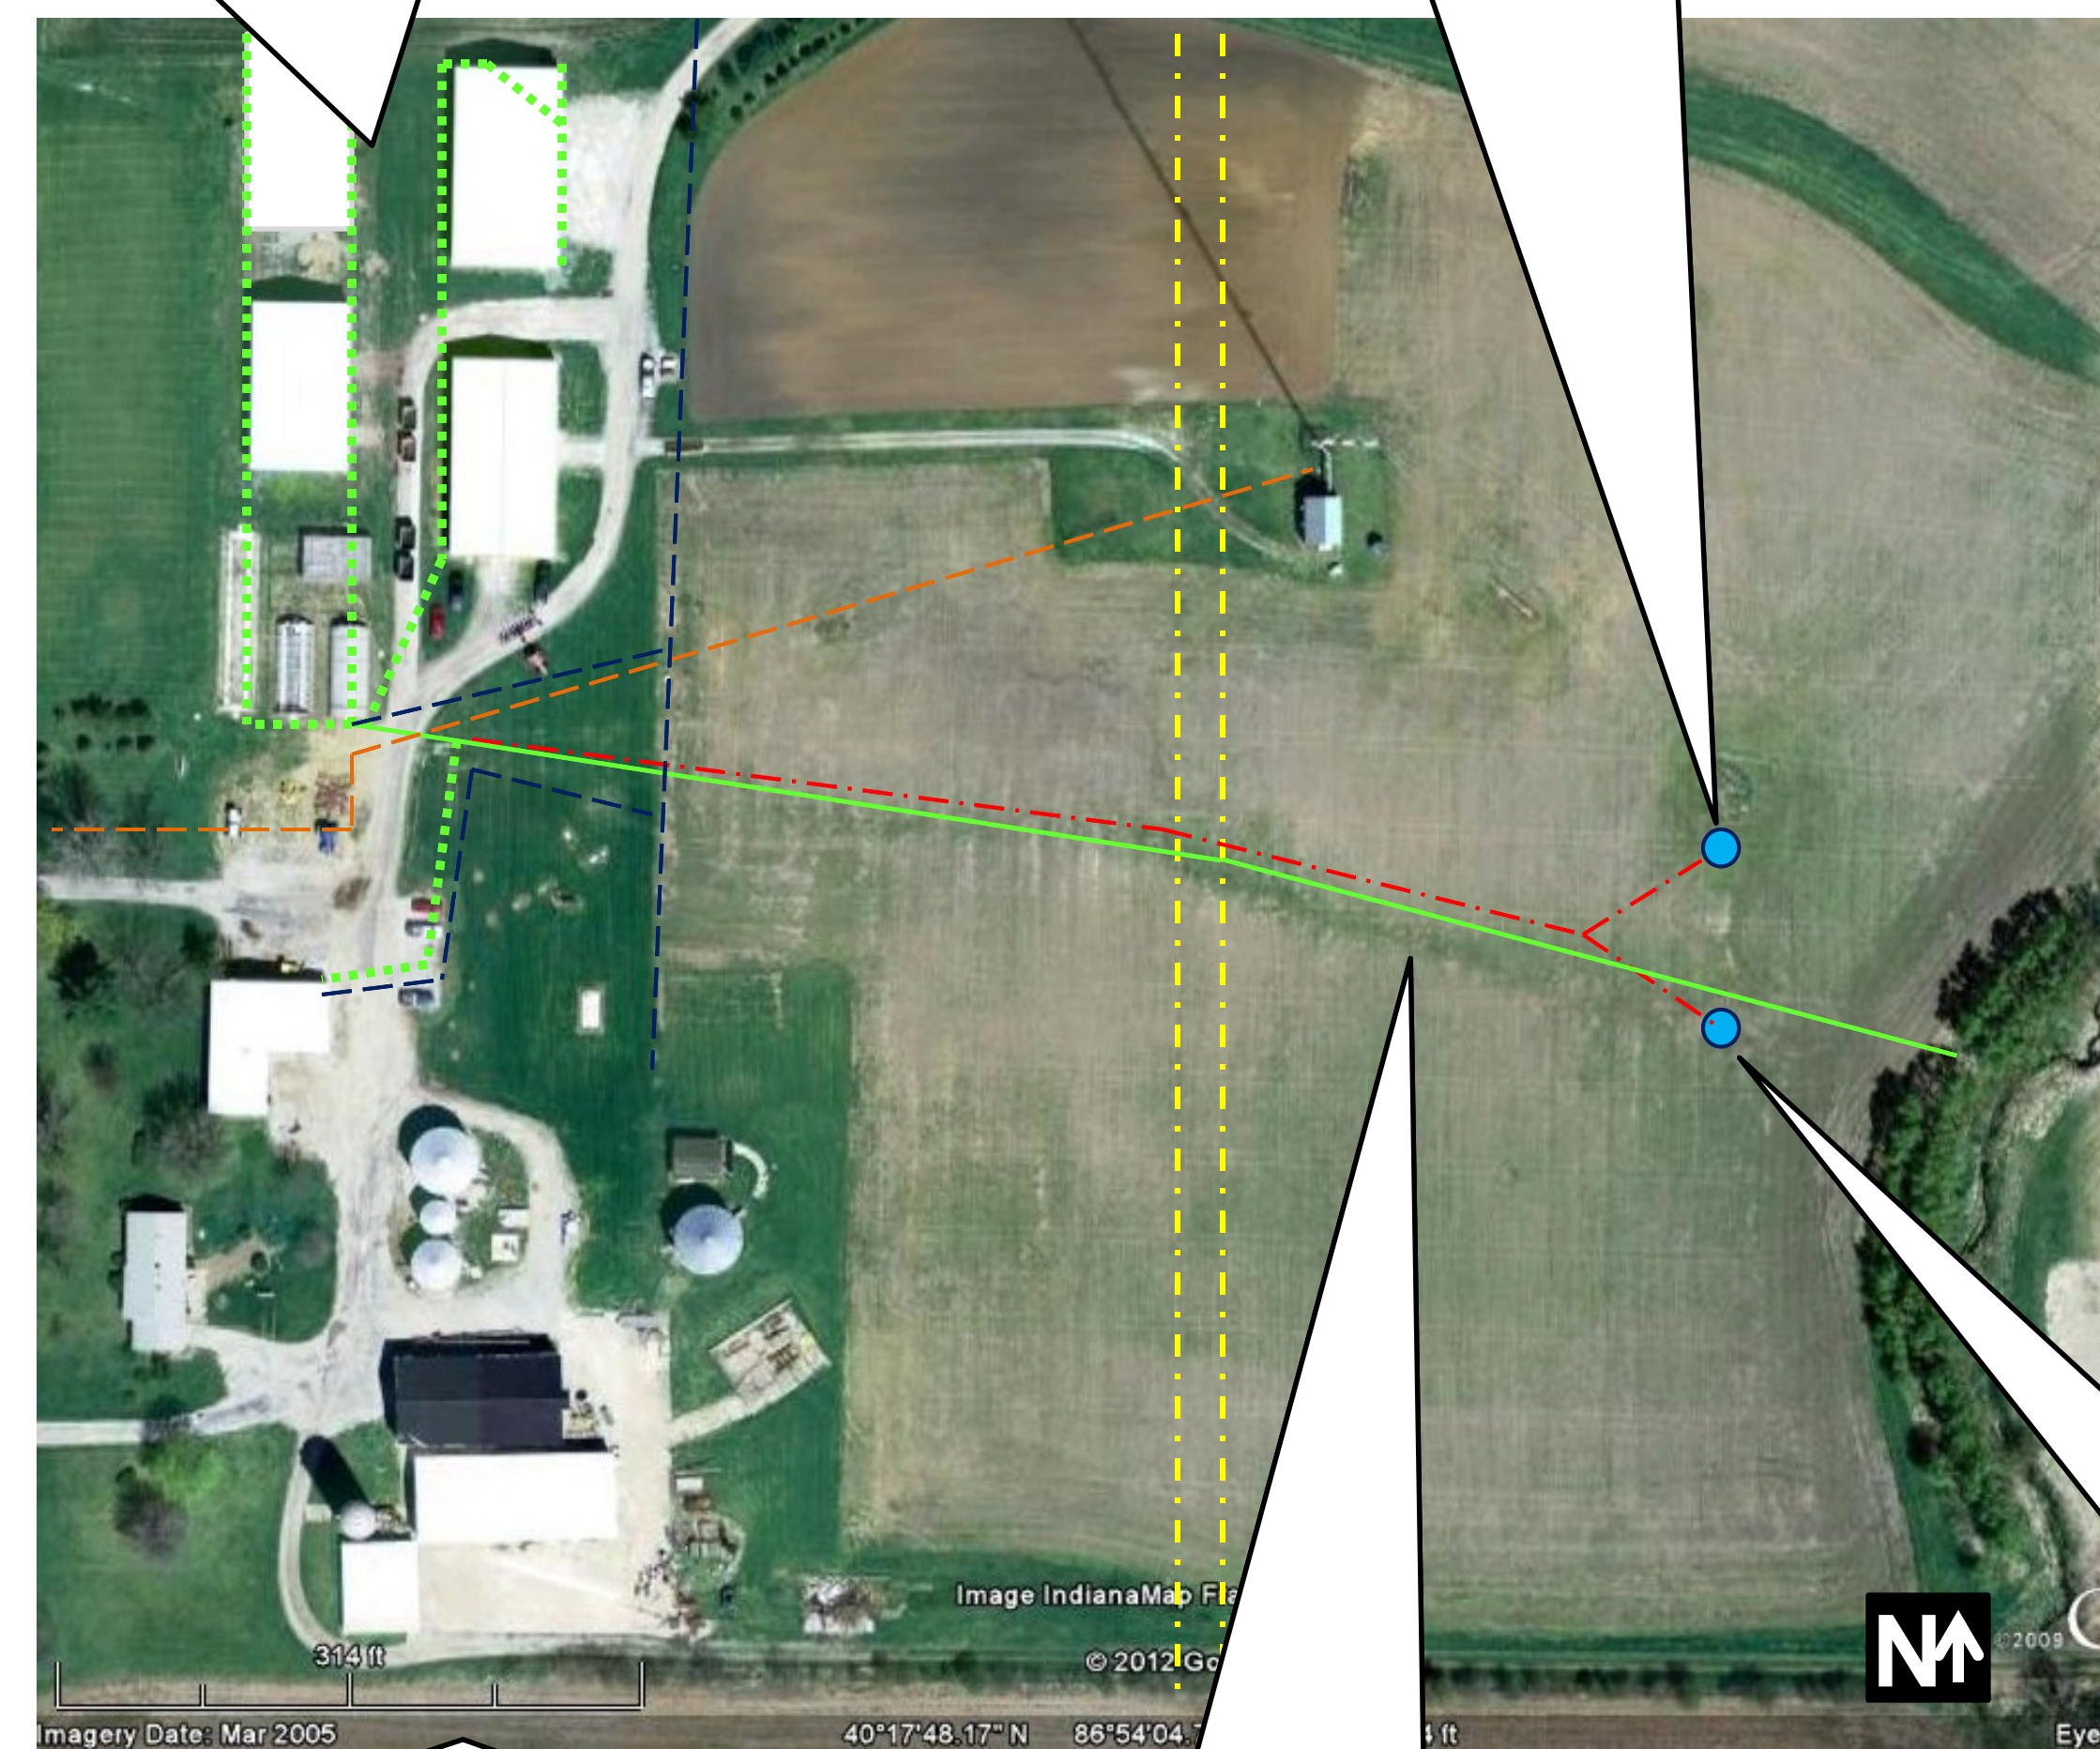
Figure 1. Arial view of site

- Tile needing replacement
- - - Other tiles (tie into new tile)
- - - 24 Pair cable
- - - Wells, known water lines
- - - Gas Lines
- - - Electrical line

Given the increased runoff, and after considering alternate solutions, the best solution is to replace the existing clay tile with a 10" plastic, slotted tile in the same location as the existing tile. The location of the current and proposed tile is shown in Figure 1, the details for the design are shown in Table 2, and the elevation profile for the tile is illustrated in Figure 6. The estimated cost of this design is shown in Table 1.

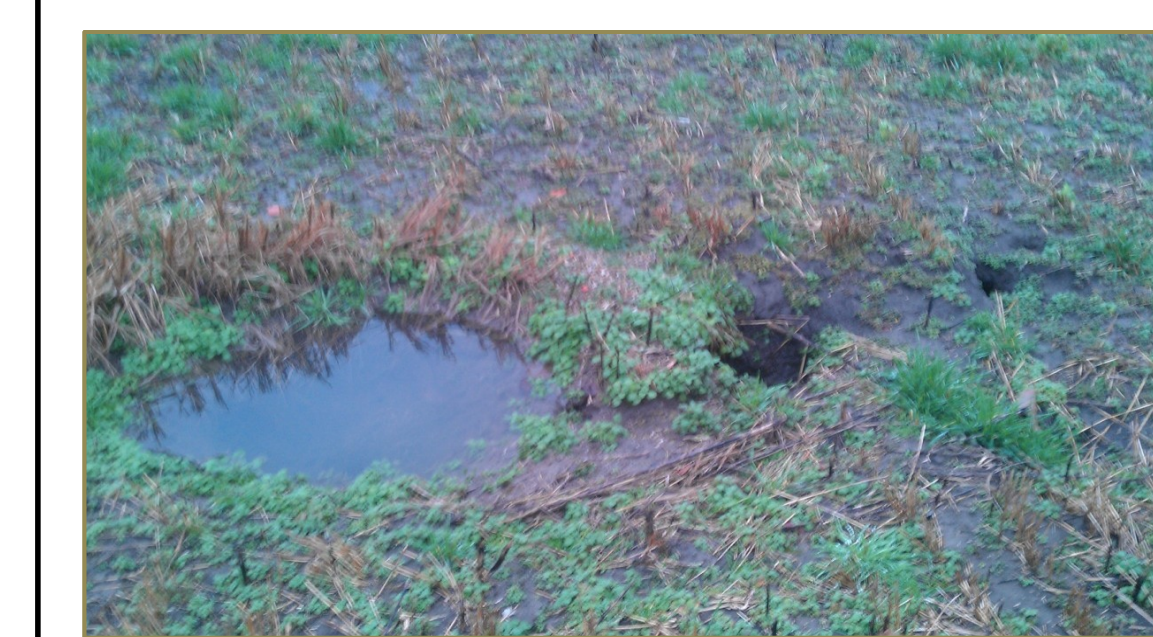
All of the runoff is currently being directed into a broken six-inch clay tile. The capacity of the tile is inadequate. The clay tile is breaking down and creating blowholes in the field (See Figure 4). Increased erosion and standing water is occurring as a result.

Figure 4. Tile blowhole and standing water

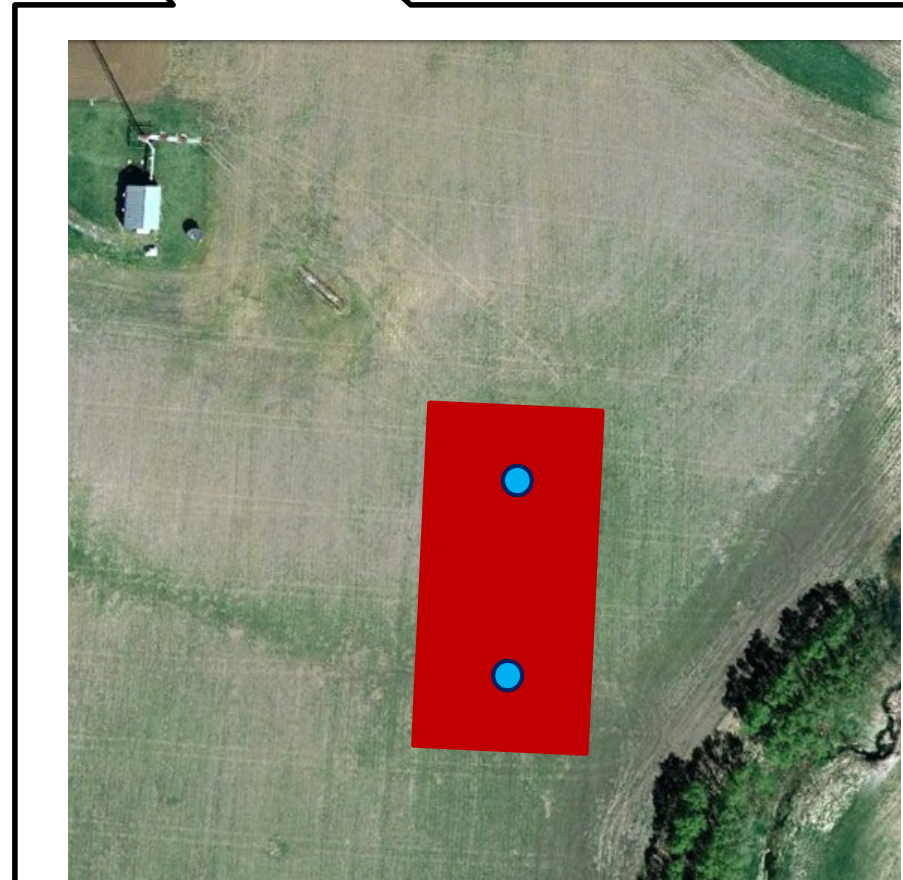
Figure 5. Well boundary

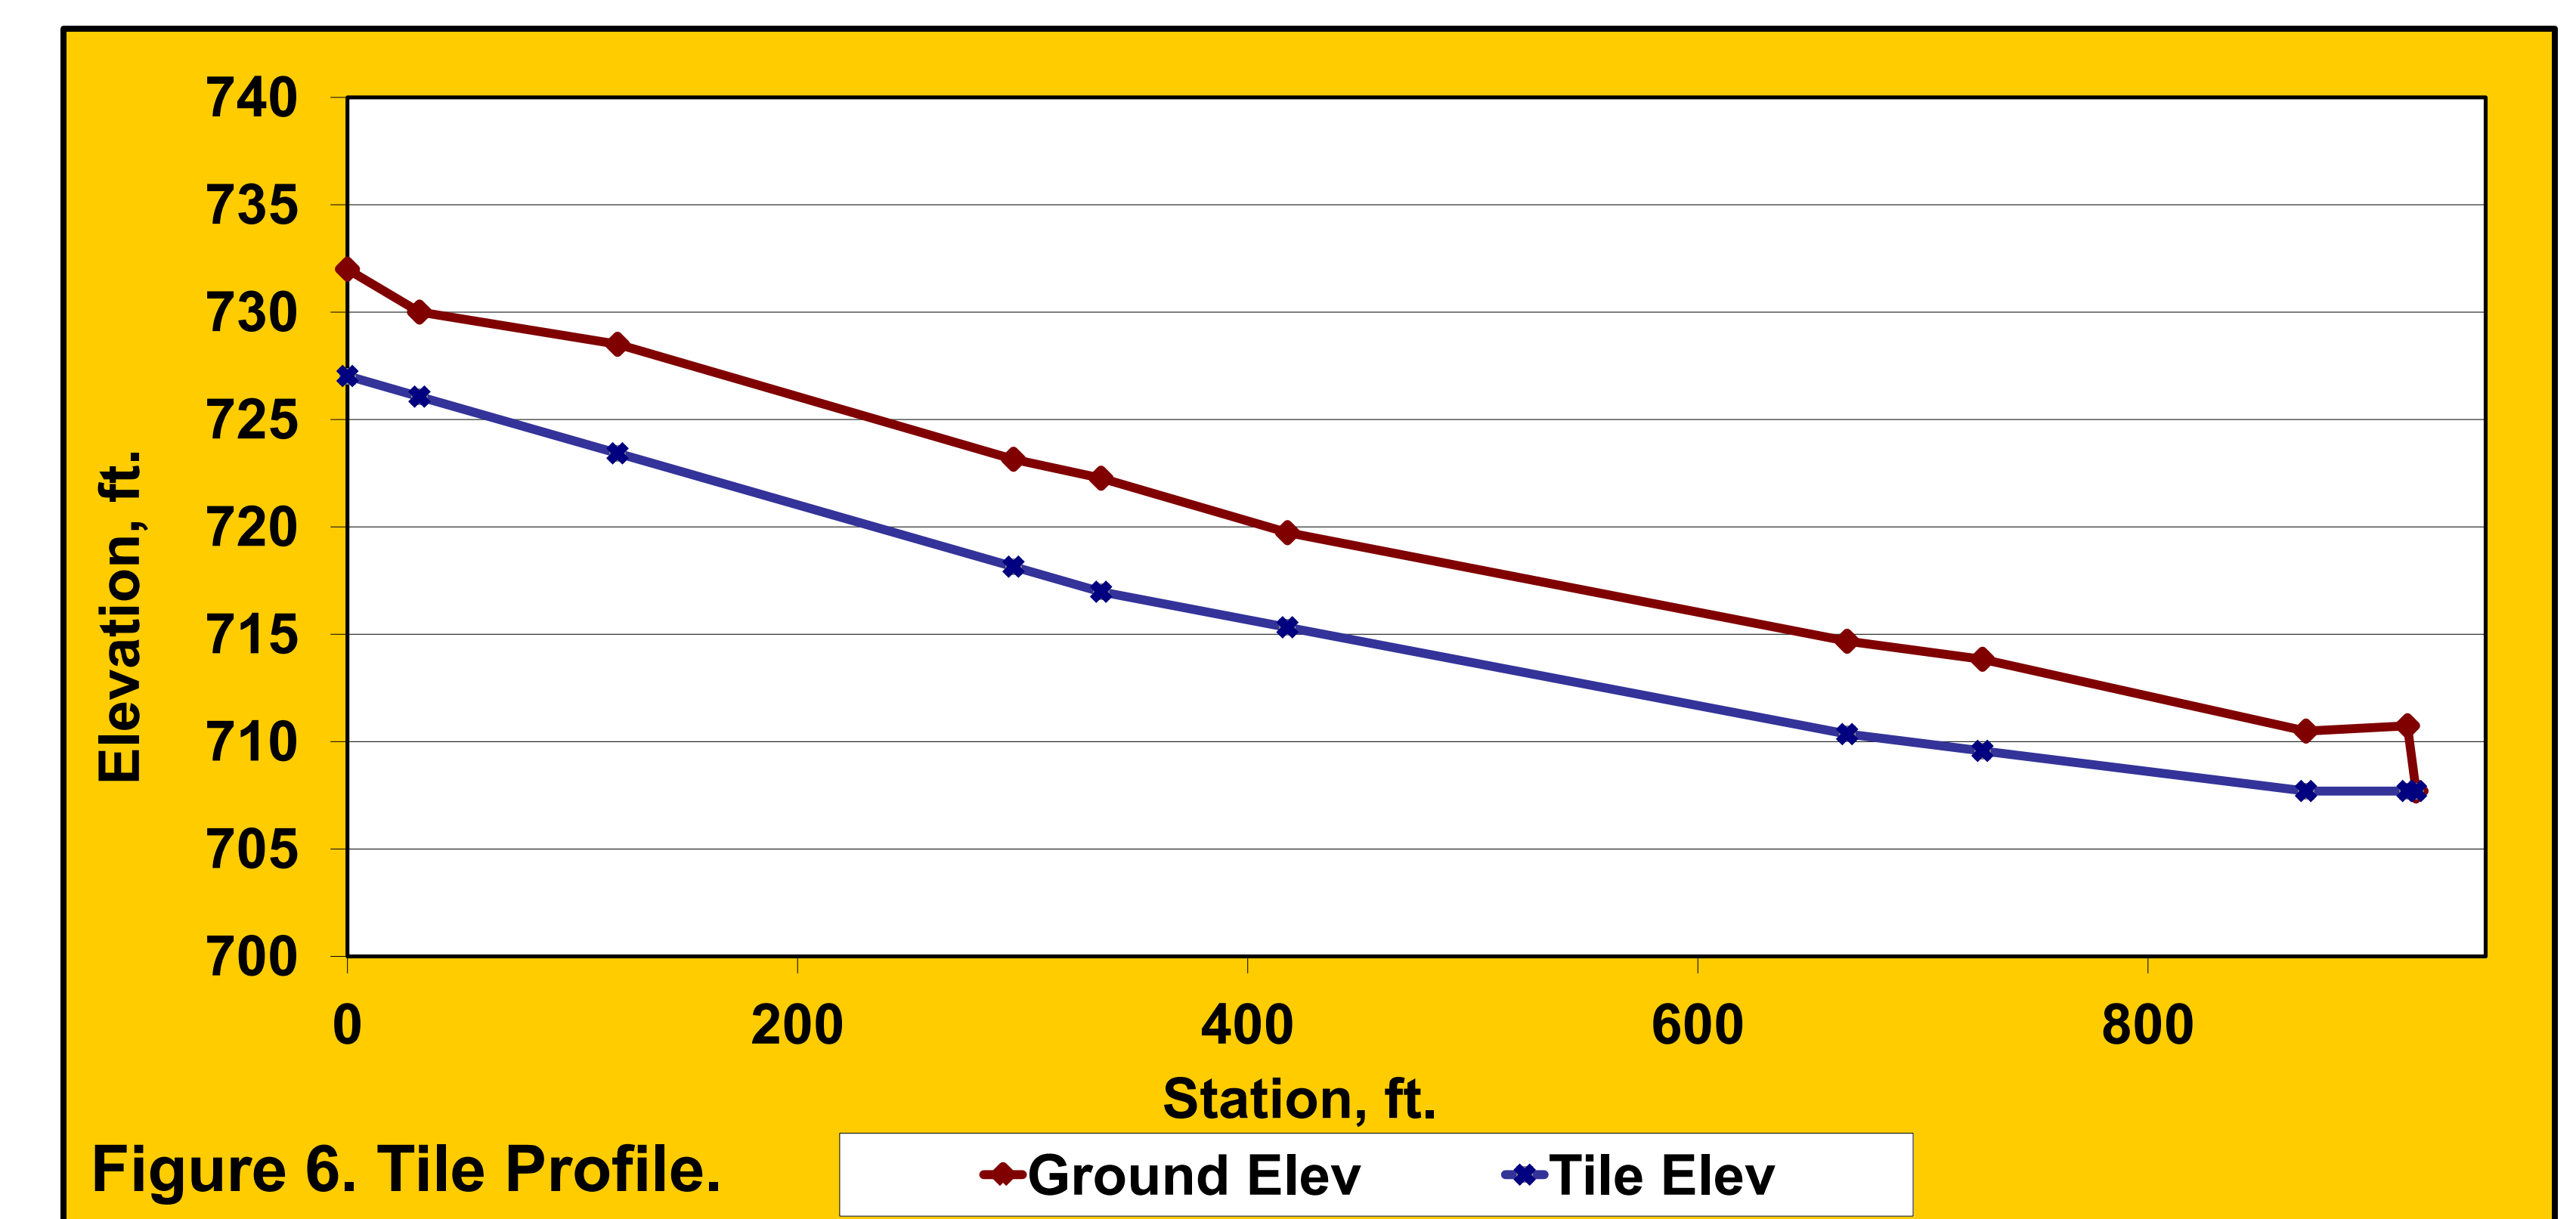
Figure 6. Tile Profile.
